National Highway
Traffic Safety
Administration

Case Veh. (A): 1999 Pontiac
 Type: Grand AM SE, 4-door sedan
 Driver: 20-year-old female
 CDC: 02-RYEW-3, 12-FDEW-1

Vehicle (B): 1993 Ford
 Type: Bronco 4x4, 2-door MPV
 Driver: 54-year-old female
 CDC: 99-ØØØØ-Ø

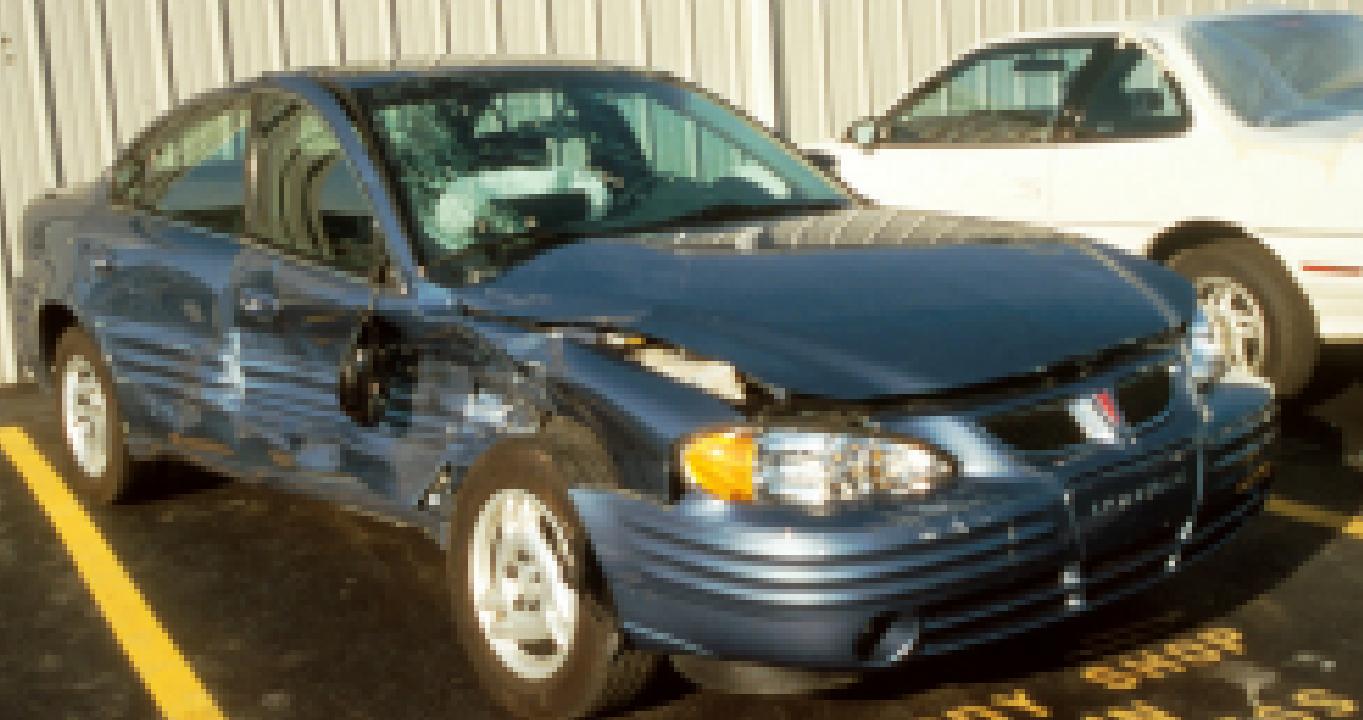
PN 3498 #15

(Slide 15) Damage to the right side of case vehicle (A) was moderate with a maximum crush of 31 cm to the right-front fender just forward of the A-pillar. The direct damage began at the rear portion of the right-front fender and extended 280 cm rearward along the right side. (Slide 16) The right-front fender was crushed, both right-side doors were damaged and jammed closed, and the right upper and lower A-pillars and B-pillars were deformed. (Slide 17) Also, the right-front wheel was damaged, but there was no change in right wheelbase. (Slide 18) The right-side impact damaged the right portion of the hood, allowing the rear edge of the hood to elevate. (Slide 19) Deformation of the right-upper A-pillar caused the right side of the windshield to break. (Slide 20) There was no damage to the left side and no change in the left wheelbase.

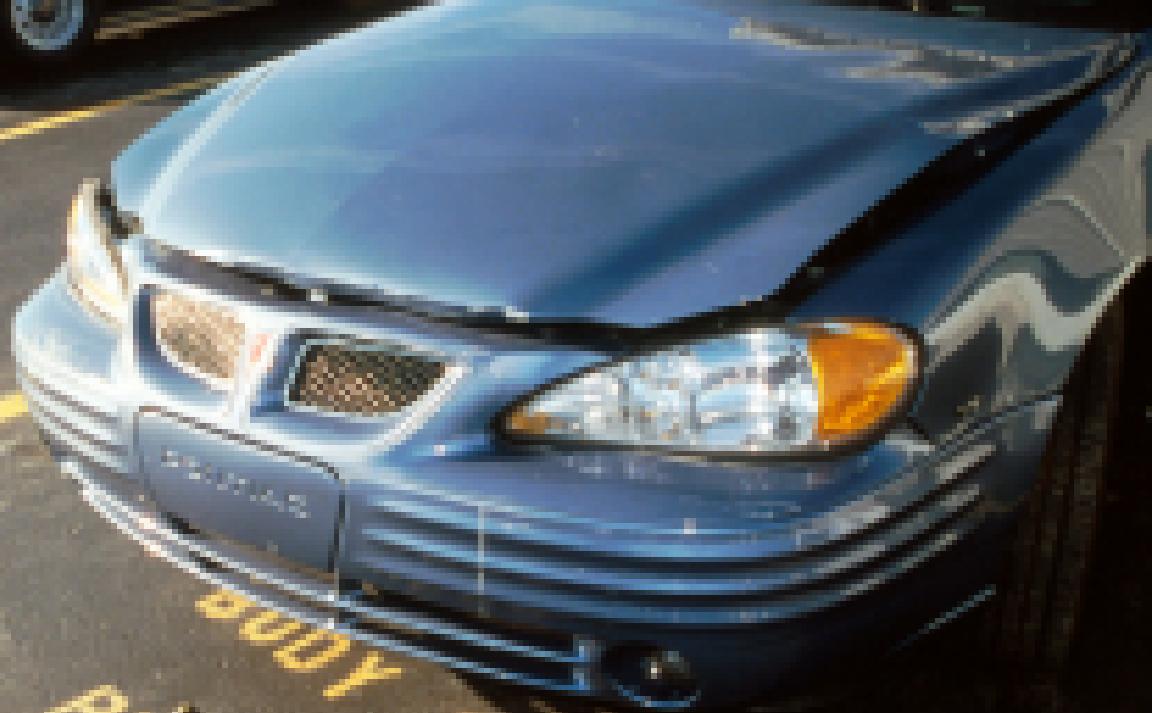
PN 3498 #21

(Slide 21) The second impact to the front of case vehicle (A) was minor with a maximum crush of 2 cm to the left-front bumper corner. The direct damage extended 139 cm across the front bumper. (Slide 22) There were scratches on the front bumper and front facia. (Slide 23) The right-front headlight was displaced, but not broken. There was no other frontal damage from the second impact.

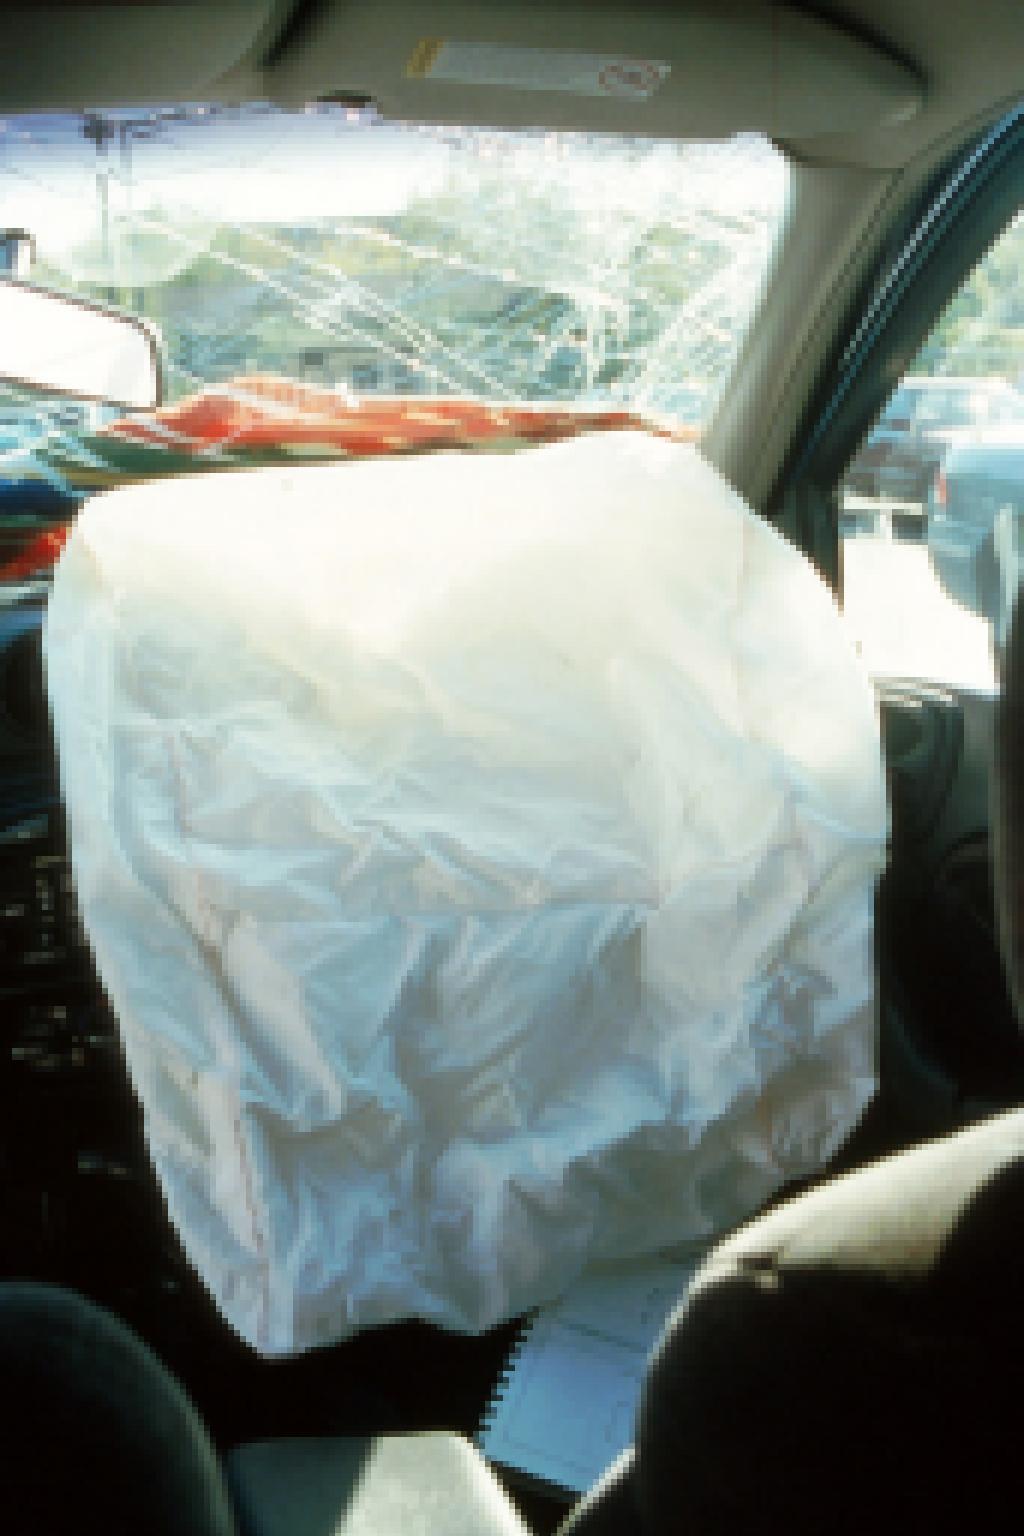
PN 3498 #24

(Slide 24, 25) This vehicle is equipped with steering-wheel and passenger frontal impact airbags, which may have deployed during the first impact to the right side or the minor frontal impact. (Slide 26) There was makeup on the steering-wheel airbag skin, but no visible damage. (Slide 27) There was no damage to the steering wheel and no rotation of the steering column. (Slide 28, 29) There was no damage to the upper or mid portions of the instrument panel, and the knee bolster had a 7-cm scuff mark from driver contact.

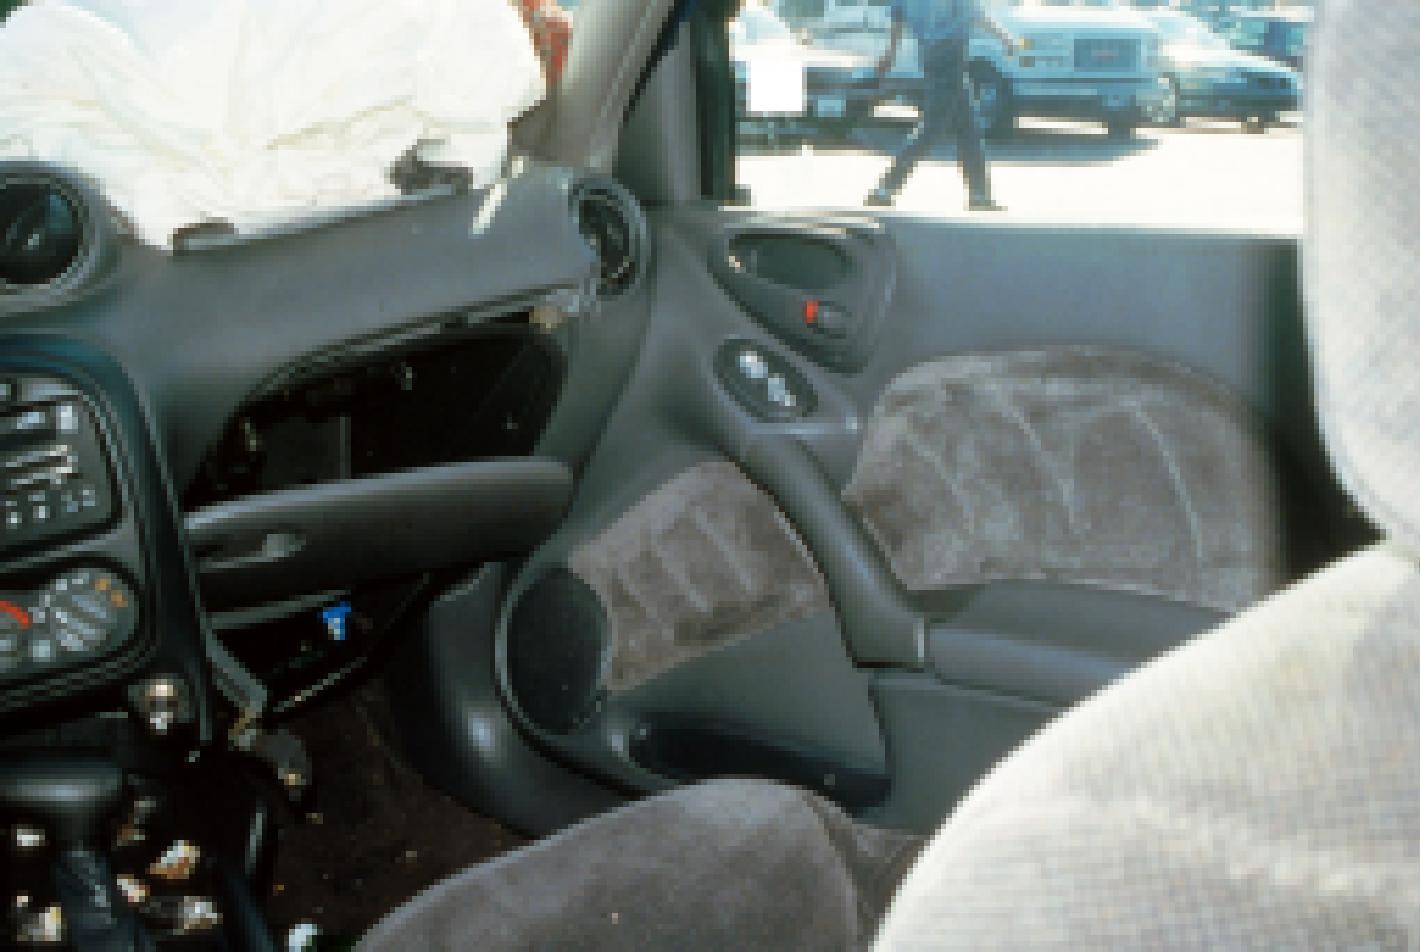
PN 3498 #31

(Slide 30, 31, 32) The center console, glove compartment, and the ashtray were damaged and, in the right-front seat area, the door hardware and armrest were damaged. (Slide 33) Also, the right A-pillar, and the right-rear door panel were deformed. (Slide 34) The rear-view mirror contacted and cracked the upper-center portion of the windshield. The right-front seat backrest and cushion were damaged, and the seatback was rotated to the right due to door intrusion. Also, the right-front seat adjuster was jammed.

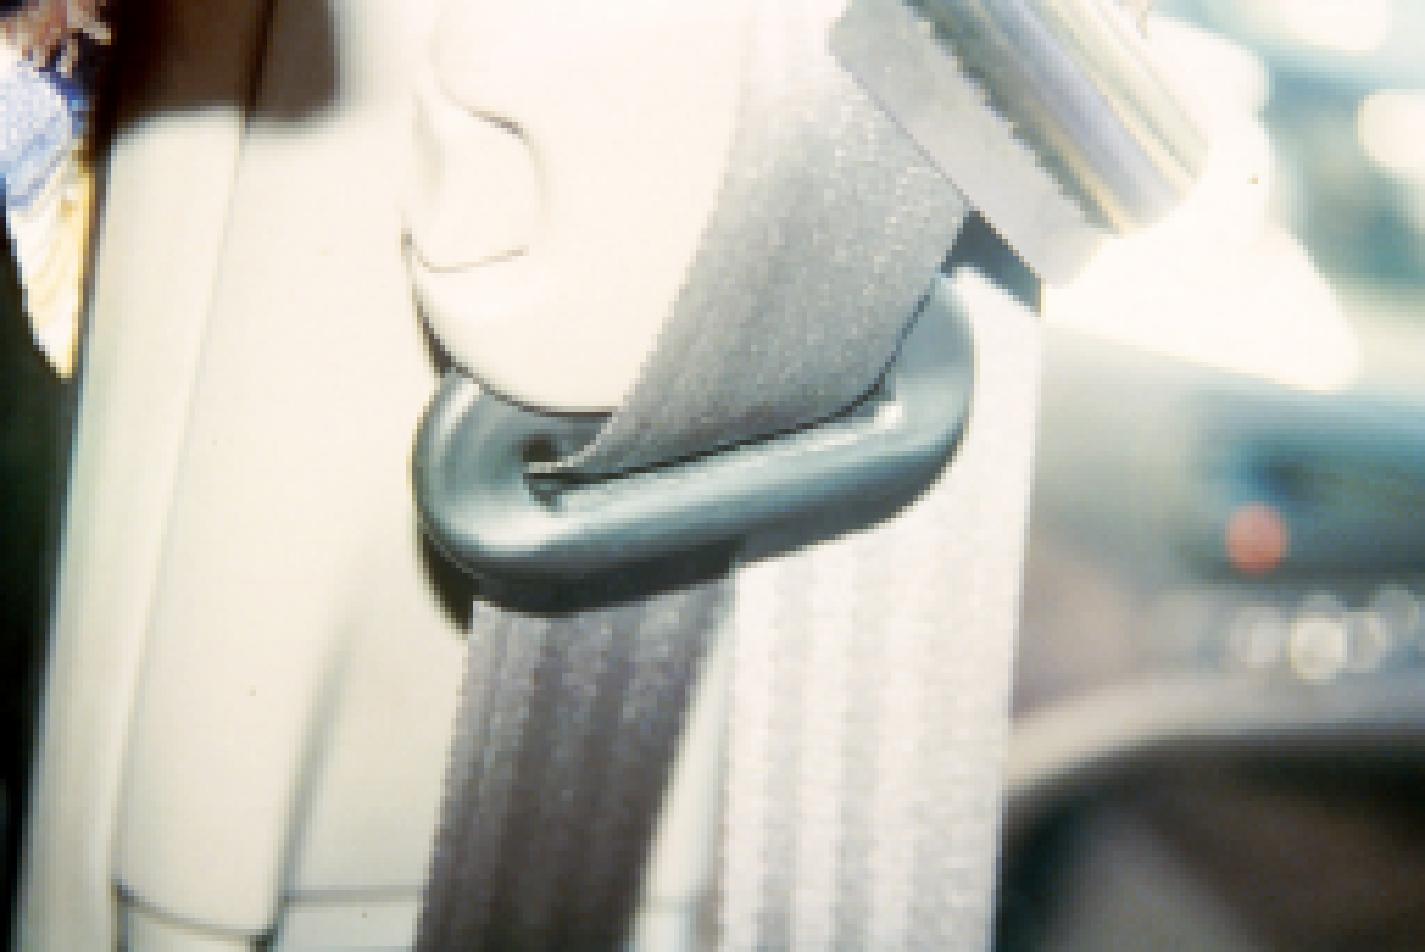
PN 3498 #35

(Slide 35, 36, 37) The 20-year-old female driver was wearing the 3-point belt, as evidenced by a webbing imprint on the D-ring from the shoulder portion of the webbing and, damage to the plastic covering the belt retractor system. She reportedly had the seat in the full-forward seat track position, and the tilt steering-wheel in the lowest position. Her right hand was reportedly on the steering wheel and her left hand was on her left leg. The shoulder-belt anchor point was adjusted to the mid position on the B-pillar.
